Structural Test Documentation and Results for the McDonnell Douglas All-Composite Wing Stub Box

Dawn C. Jegley and Harold G. Bush
Langley Research Center, Hampton, Virginia

April 1997

**National Aeronautics and
Space Administration
Langley Research Center
Hampton, Virginia 23681-0001**

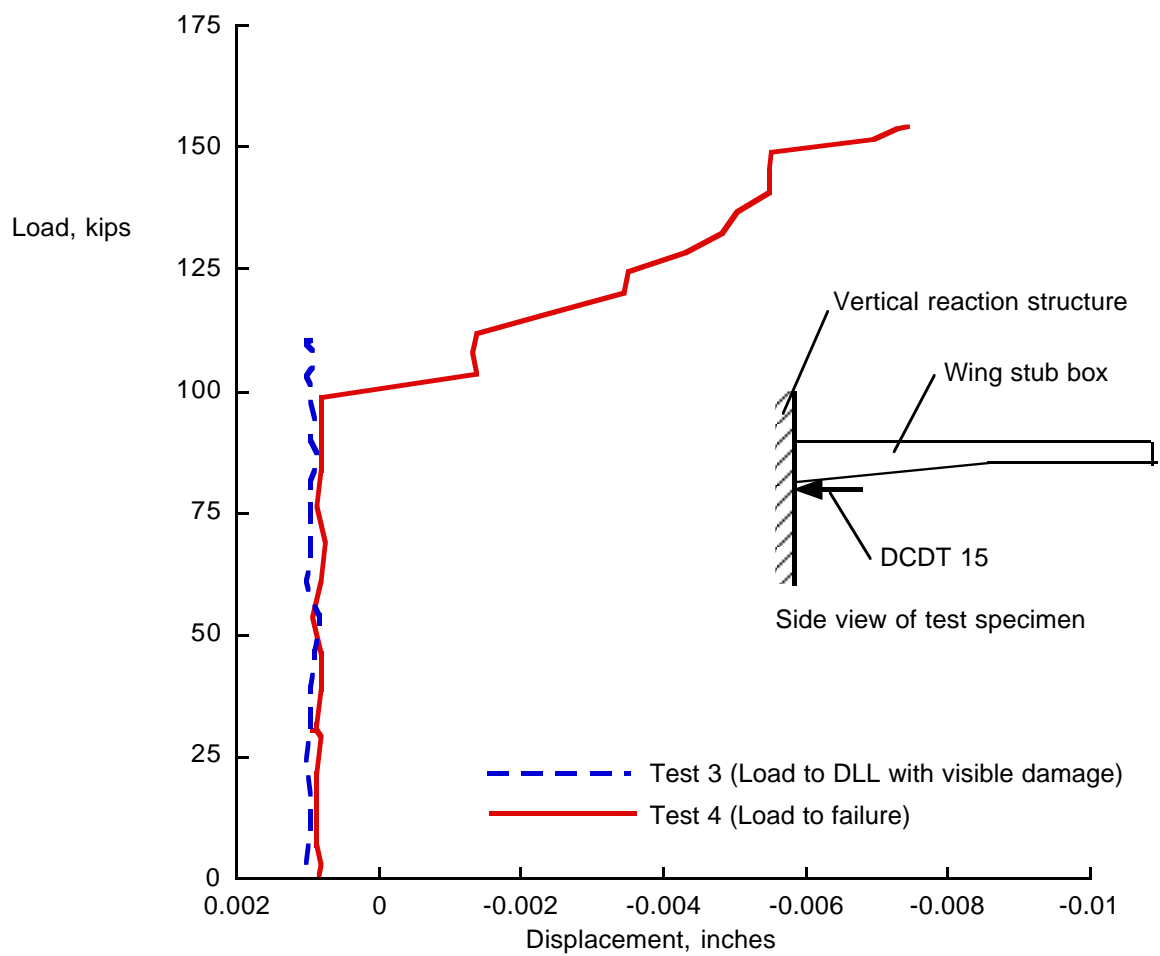
Figure 30. Displacement of vertical reaction structure slotted plate near the rear spar.

The displacement of the vertical reaction structure is shown for the last two tests in figure 30. The displacement of the vertical reaction structure never varied by more than 0.00015 inches during test 3, which had a maximum load of 110 kips. The displacement of the vertical reaction structure never varied by more than 0.00011 inches during the final test for loads less than 100 kips. However, for load levels greater than 100 kips in the last test, the displacement appeared to increase to almost 0.008 inches. Prior to each test, each DCDT was examined to verify that it would slide easily as the probe tip was moved. After the last test, examination of this DCDT revealed that the probe was jammed into its base and was not movable. No explanation for this damage could be found. Therefore, the data recorded from this DCDT during the last test must be considered suspect. There was no reason to believe that data recorded during the third test for this DCDT are in error.

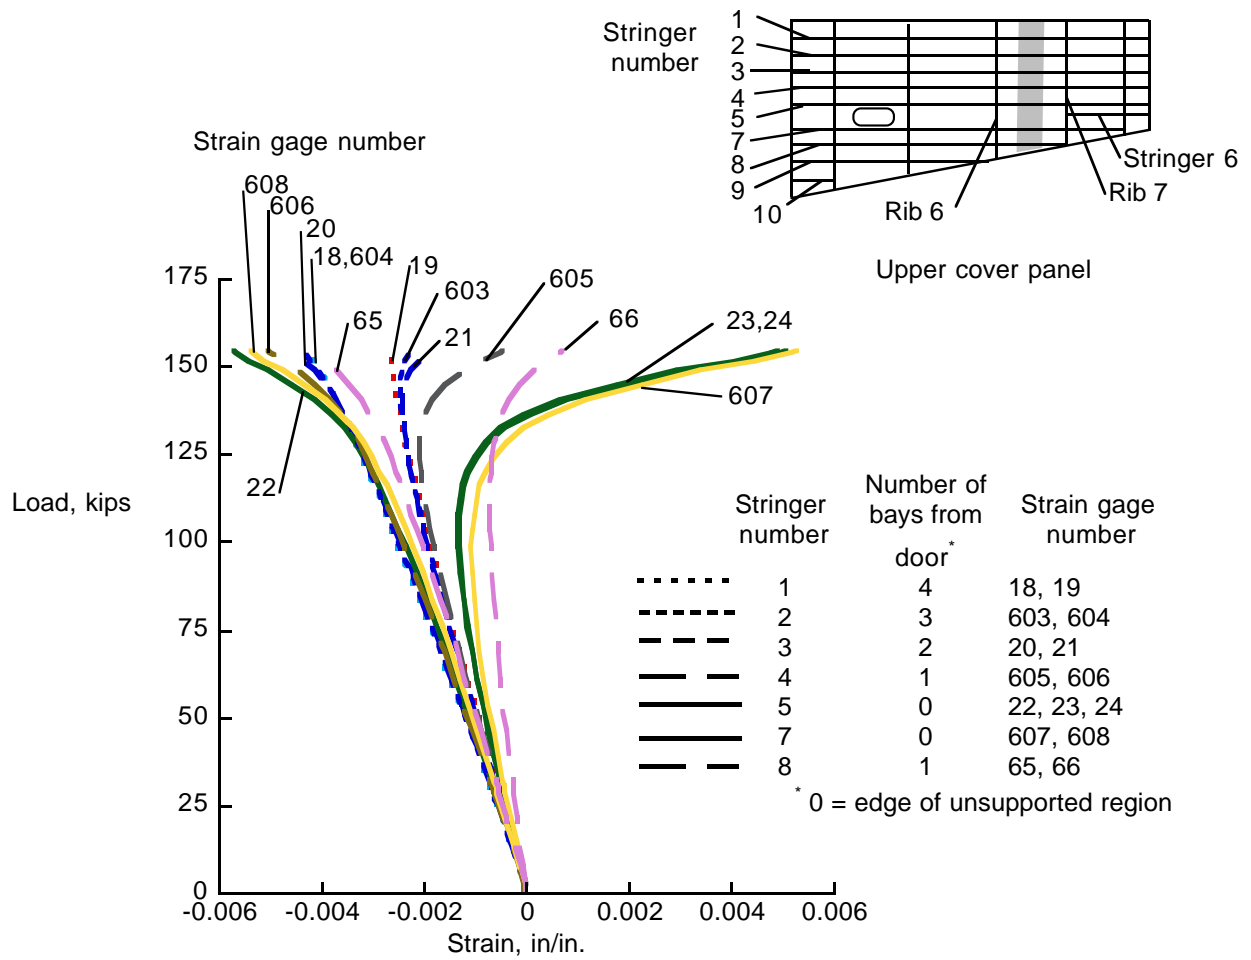
Figure 31. Strains for stringers in upper cover panel between ribs 6 and 7.

The strains measured between ribs 6 and 7 are shown in figure 31. The solid lines represent strains from strain gages 22, 23, 24, 607 and 608, which are on the stringer blades and skin at the edge of the unsupported region. The dashed lines represent strains from strain gages which are farther away from the unsupported region. Results from strain gages 23, 24 and 607, which are on the blades on the edge of the unsupported region, indicate the onset of nonlinear behavior at a load of approximately 100 kips and indicate pronounced nonlinear behavior starting at approximately 125 kips. Results from strain gages 18 and 19, which are the farthest from the unsupported region in this row, indicate nonlinear behavior away from the unsupported regions begins at a load of approximately 130 kips.

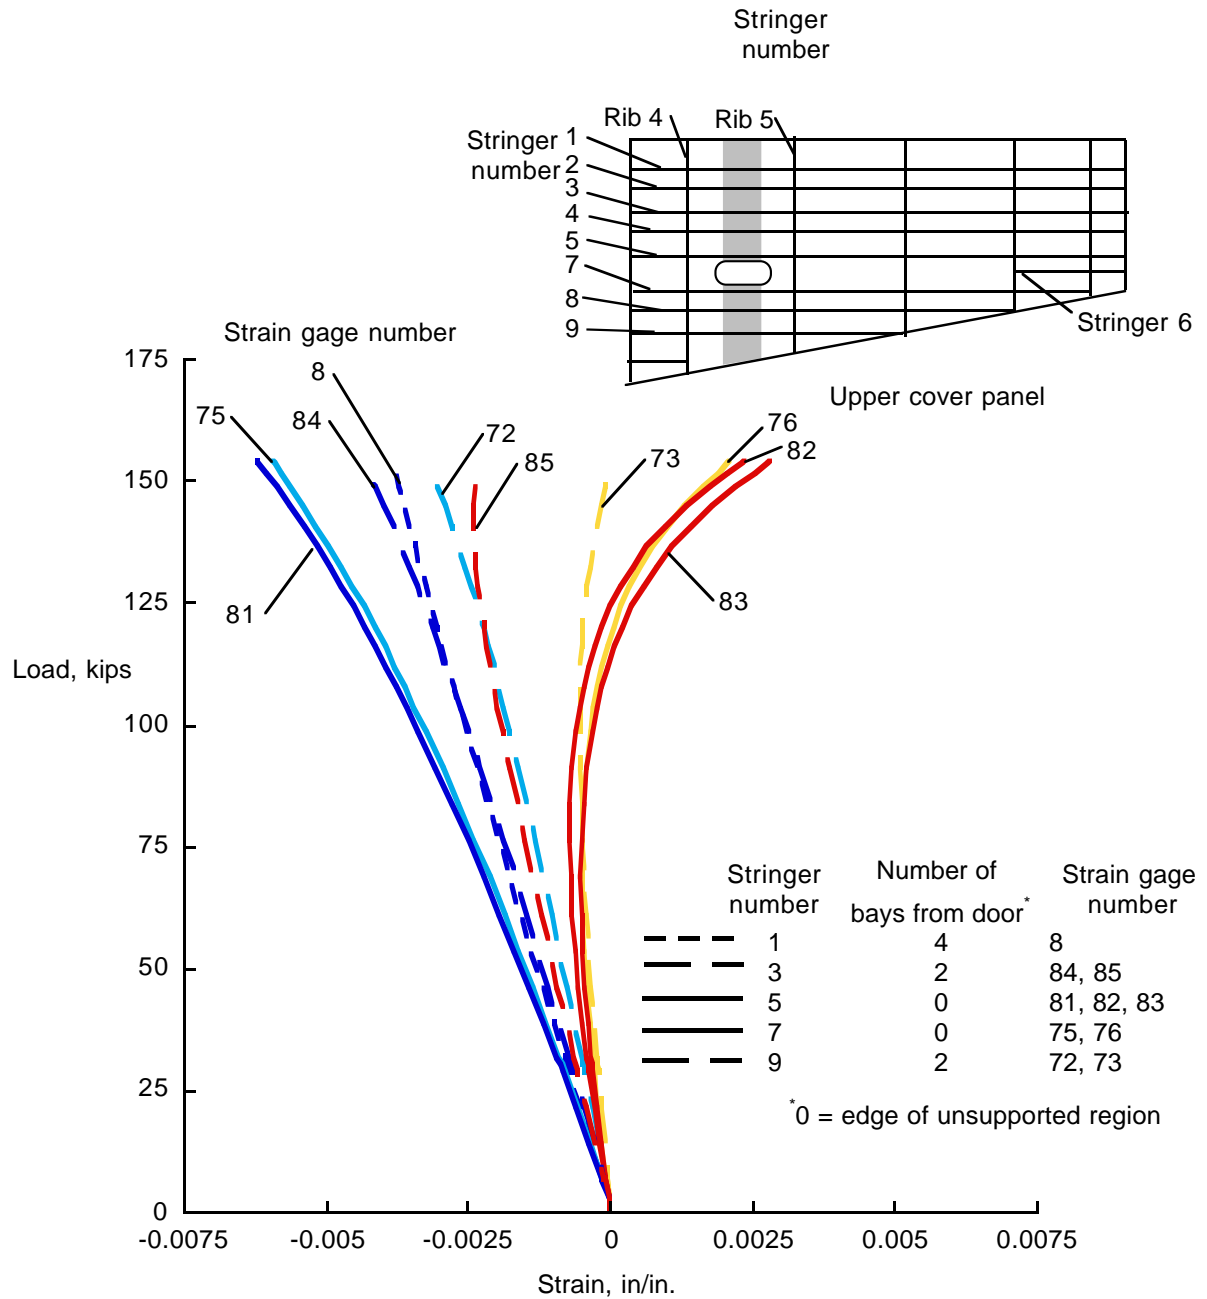
Figure 32. Strains at stringers for upper cover panel between ribs 4 and 5.

The strains measured between ribs 4 and 5 are shown in figure 32. The solid lines represent strain gages 75, 76, 81, 82 and 83 which are on the stringer blades and skin at the edge of the bay containing the access door. The dashed

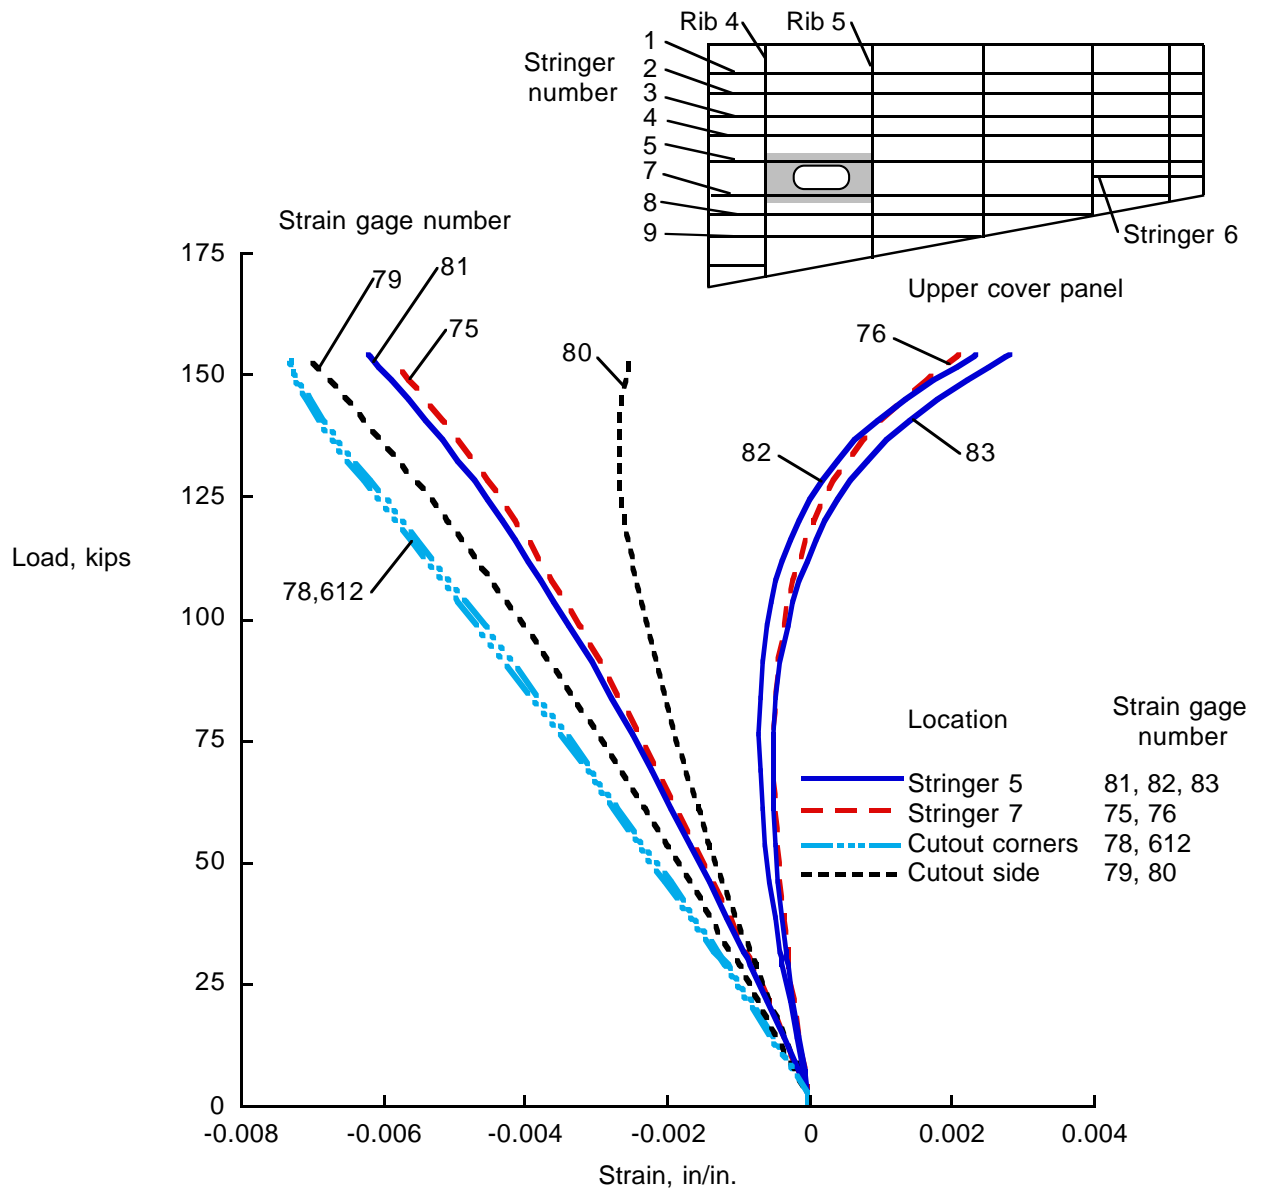
Figure 33. Strains for the region around the access door.

The strains measured in the region immediately around the access door are shown in figure 33. The strains in stringer 5 are shown as solid lines. The strains in stringer 7 and at the cutout edges are shown as dashed lines. Strain gages 78 and 612 are located at the corners of the access-door cutout on the external surface and record approximately linear strain for loads lower than 150 kips. The magnitude of the maximum strain recorded by these strain gages is approximately 0.007 in/in. Strain gages 79 and 80 are on the internal and external surfaces, respectively, at the side of the cutout. Strains at the side of the cutout are less than strains at the corners, and nonlinear behavior is evident at the sides but not at the corners. The nonlinearity in the behavior of the strain gages on the stringers is more dramatic than in the skin, although higher strains occur in the skin. The interaction between the access-door cutout edge and the bolt holes around the access door leads to high strains around the access-door cutout. The nonlinearity is caused by the large unstiffened region, i.e., the large cutout in the skin. The access-door carries little load and contributes little to the stiffness of the cover panel.

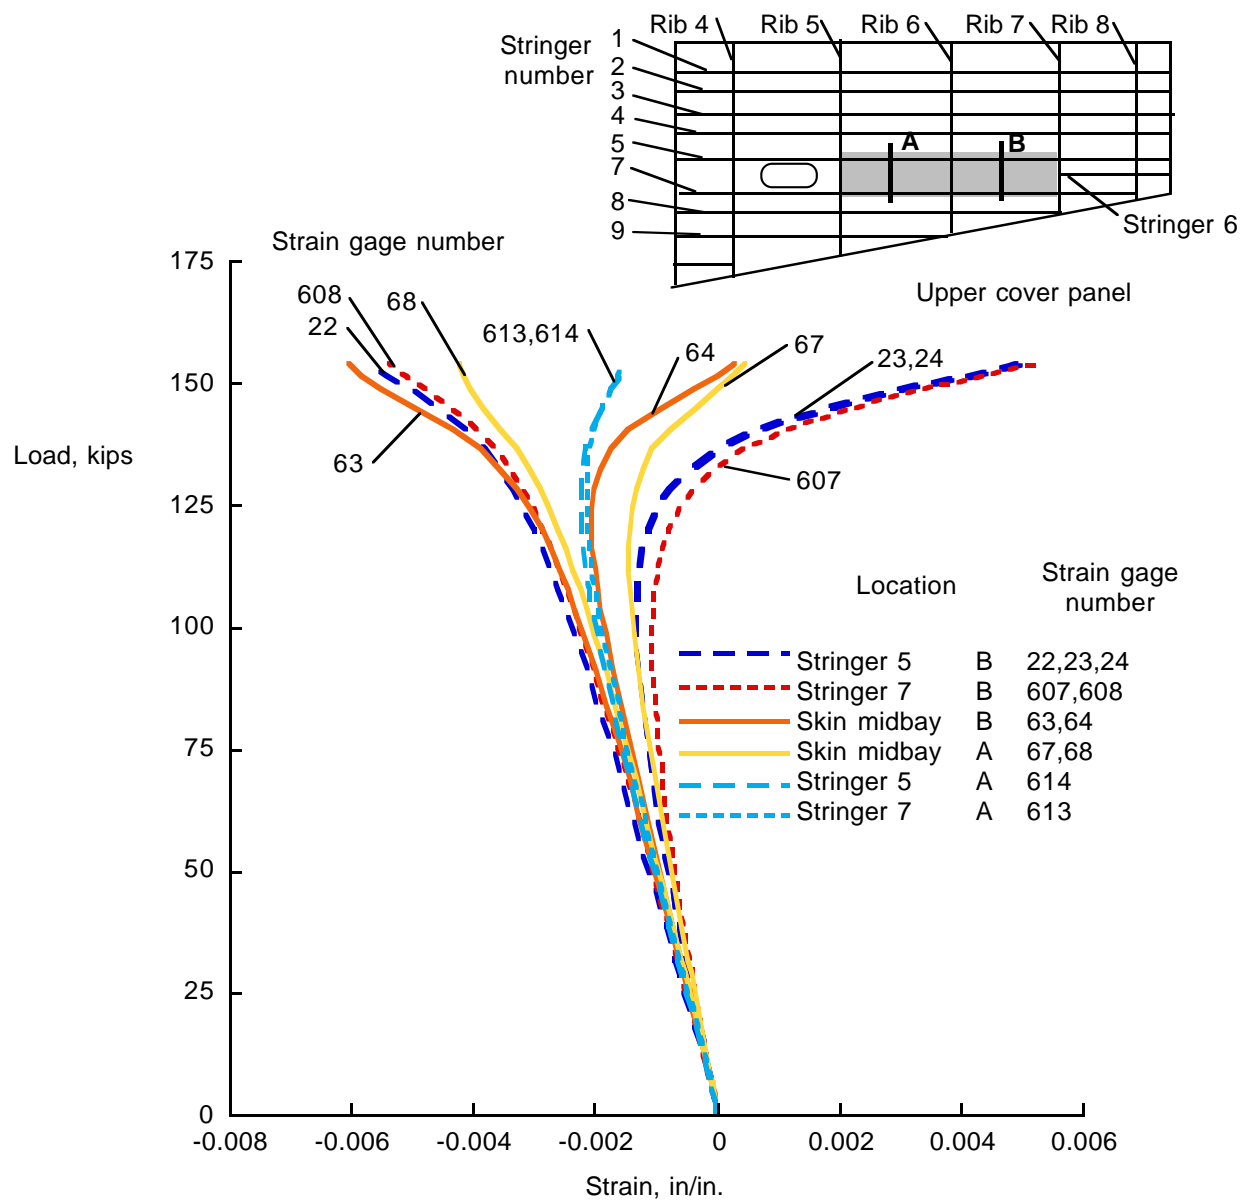
Figure 34. Strains in and around unsupported skin region between ribs 5 and 7.

The strains measured in the unsupported skin between ribs 5 and 7 and in adjacent stringers 5 and 7 are shown in figure 34. Location "A" in the figure is half way between ribs 5 and 6. Location "B" in the figure is half way between ribs 6 and 7. The results from strain gages on the skin are shown as solid lines while the results from strain gage at the stringers are shown as dashed lines. All strain results in this region indicate nonlinear behavior. The most pronounced nonlinearity can be seen in the results from interior strain gages 23, 24 and 607, which are on the stringers surrounding the unsupported skin between ribs 6 and 7. Comparison of results from back-to-back strain gages 63 and 64, which are on the skin between ribs 6 and 7, suggest that an instability initiates at approximately 135 kips. Nonlinear behavior initiates prior to that load level. Similarly, results from strain gages 67 and 68, which are between

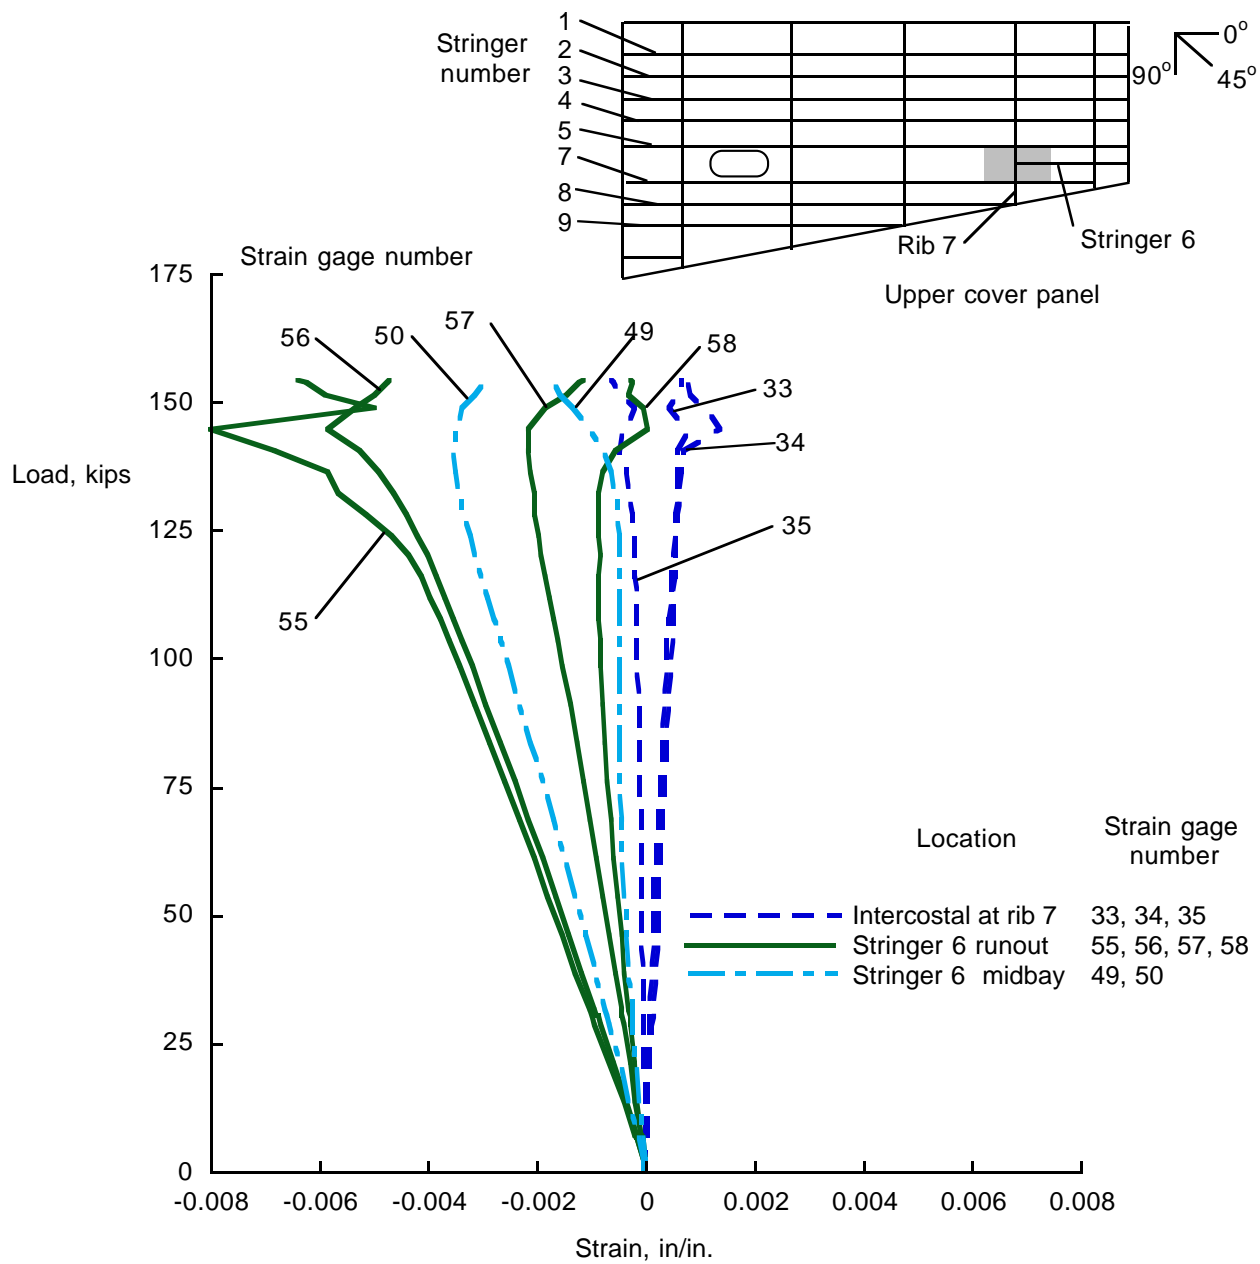
Figure 35. Strains for stringer 6 runout and intercostal at rib 7.

The strains measured on the runout of stringer 6 and at the intercostal at the intersection of rib 7 and stringer 6 are shown in figure 35. All strain gages are oriented axially except for strain gage 34, which is oriented 45 degrees to the stringers, and for strain gage 35, which is oriented 90 degrees to the stringers. All strain gage results indicate linear behavior with no pronounced discontinuities in slope for loads less than 120 kips. Nonlinearity in the load-strain behavior in the runout at stringer 6, indicated by strain gages 55, 56 and 58, begins at a load of approximately 120 kips. Nonlinear behavior initiates between 130 and 140 kips for strain gages 57, 35, 49 and 50. A strain reversal occurs at a load of 140 to 145 kips at strain gages 33, 34, and 35 on the intercostal at rib 7 and at strain gages 55, 56, 57, and 58 on the stringer at the runout. This reversal also occurs on stringer 6 away from the runout at strain gages 49 and 50, though no pronounced discontinuities in slope occur at strain gages 49 and 50. Discontinuities in slope occur in strain gages 55, 56, 57, and 58 at 145 kips. Discontinuities in slope occur at strain gages 33 and 34 at 140 kips, 145 kips and at 150 kips. A series of local failures would explain this behavior.

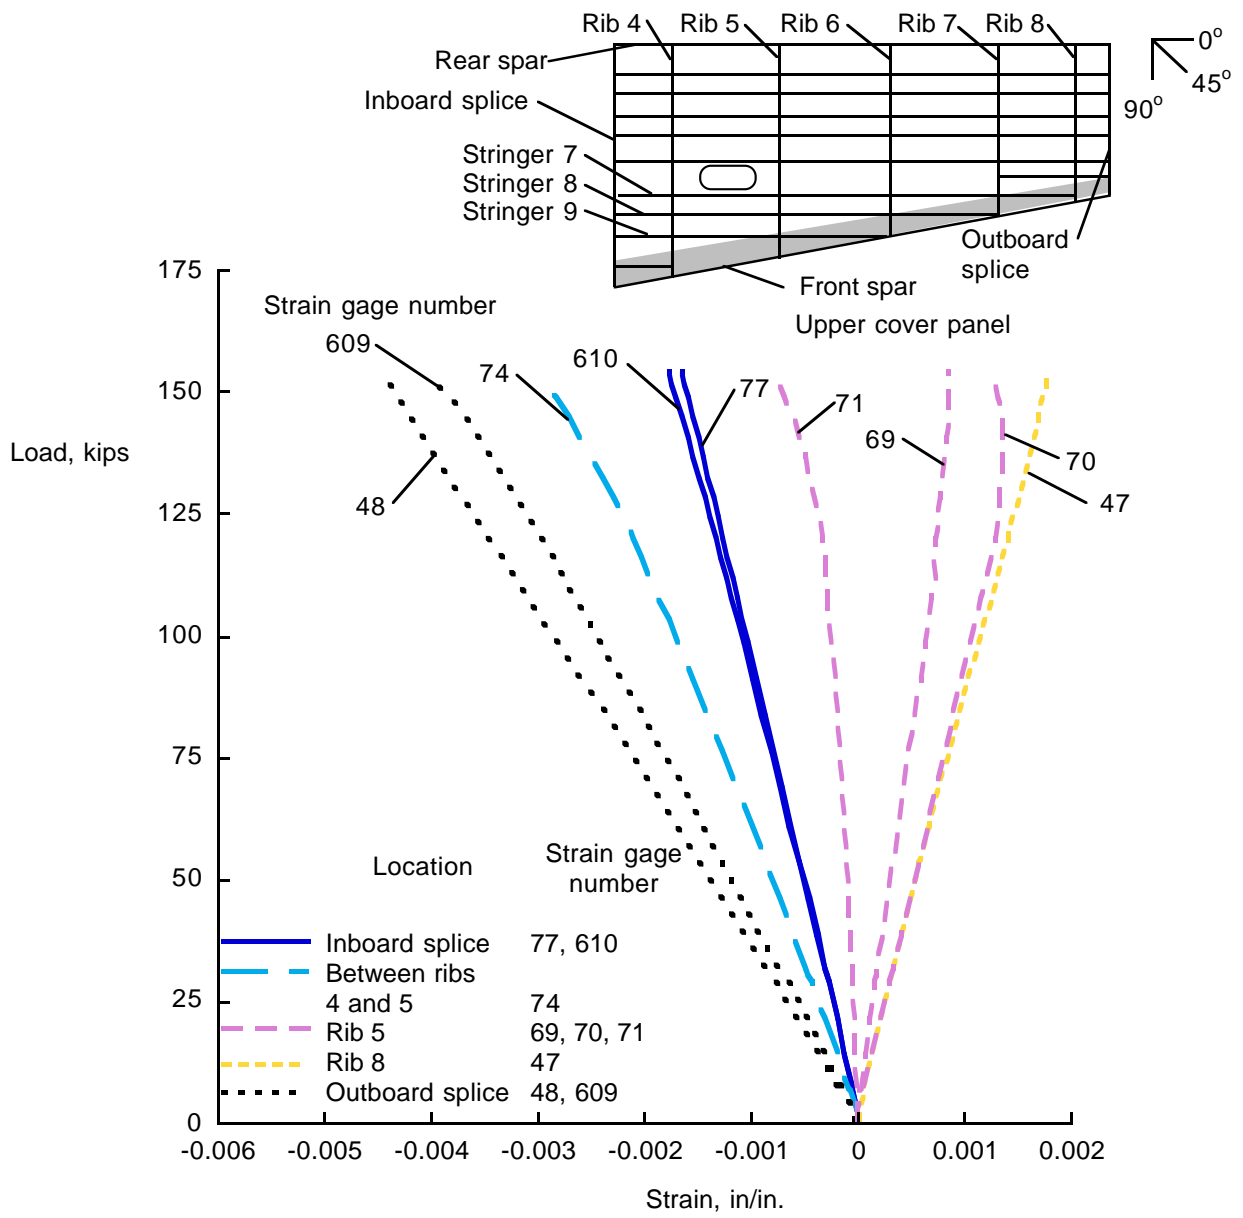
Figure 36. Strains for upper cover panel at the front spar.

The strains measured in the upper cover panel at the front spar are shown in figure 36. The solid lines in the figure represent strains at the inboard splice between the load-transition structure and the composite stub box. The dashed lines represent strains further outboard on the stub box. Strain gages 48, 74, 77, 609, 610 are parallel to the front spar (-13 degrees to the stringers). Strain gage 47 is perpendicular to the front spar (-103 degrees to the stringers). Strain gages 69, 70, and 71 form a rosette measuring strain in the 0, 45, and 90 degree directions, respectively. The magnitude of the strain measured by these strain gages were less than 0.005 in/in. All strain gages along the front spar indicate linear behavior for load less than approximately 110 kips. Strains at the inboard splice and at rib 8 remain linear throughout the entire load range. However, nonlinear behavior initiates and a discontinuity in the slope of the load-strain relationship occurs in the 45 and 90 degree components of the rosette at rib 5 at a load of 100 kips. Nonlinear behavior

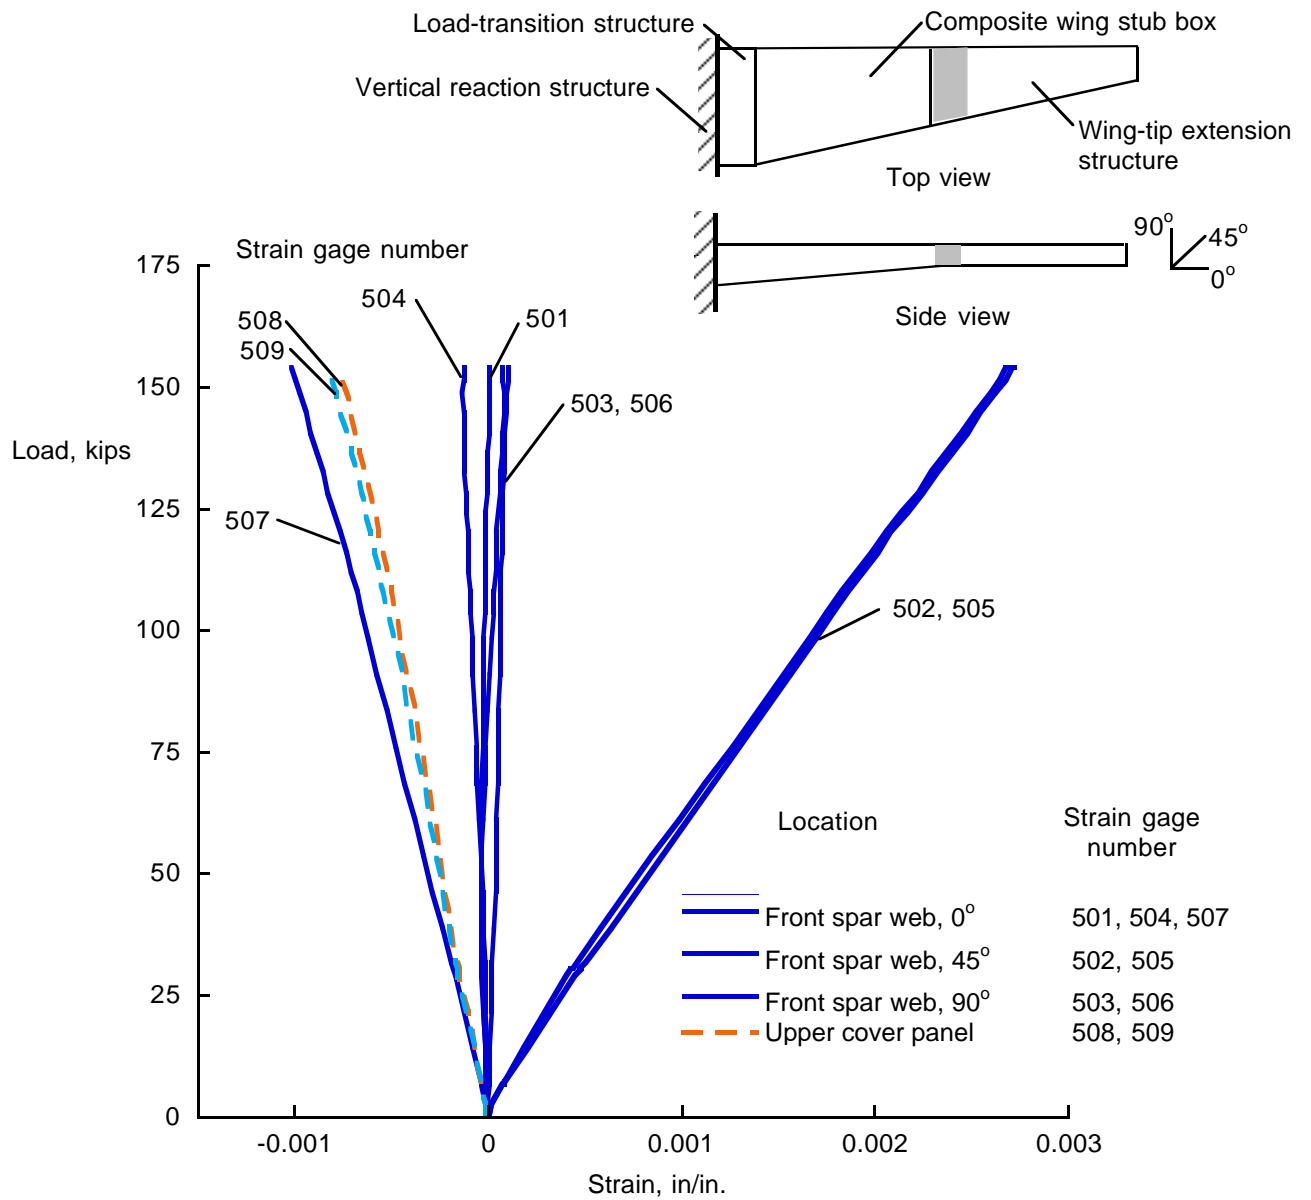
Figure 55. Strains for load-transition structure.

The strains measured for the load-transition structure are shown in figure 55. The strains measured for the wing-tip extension structure are shown in figure 56. Results for strain gages between stiffeners are shown as solid lines. Results for strain gages on stiffeners are shown as dashed lines. All strain gages are parallel to the rear spar, except those which are part of back-to-back rosettes on the front spar web of the wing-tip extension structure (strain gages 502, 503, 505 and 506). The magnitudes of the strains measured for the load-transition structure are linear to failure and do not exceed 0.002 in/in. The strains measured for the wing-tip extension structure are linear to failure and do not exceed 0.003 in/in.

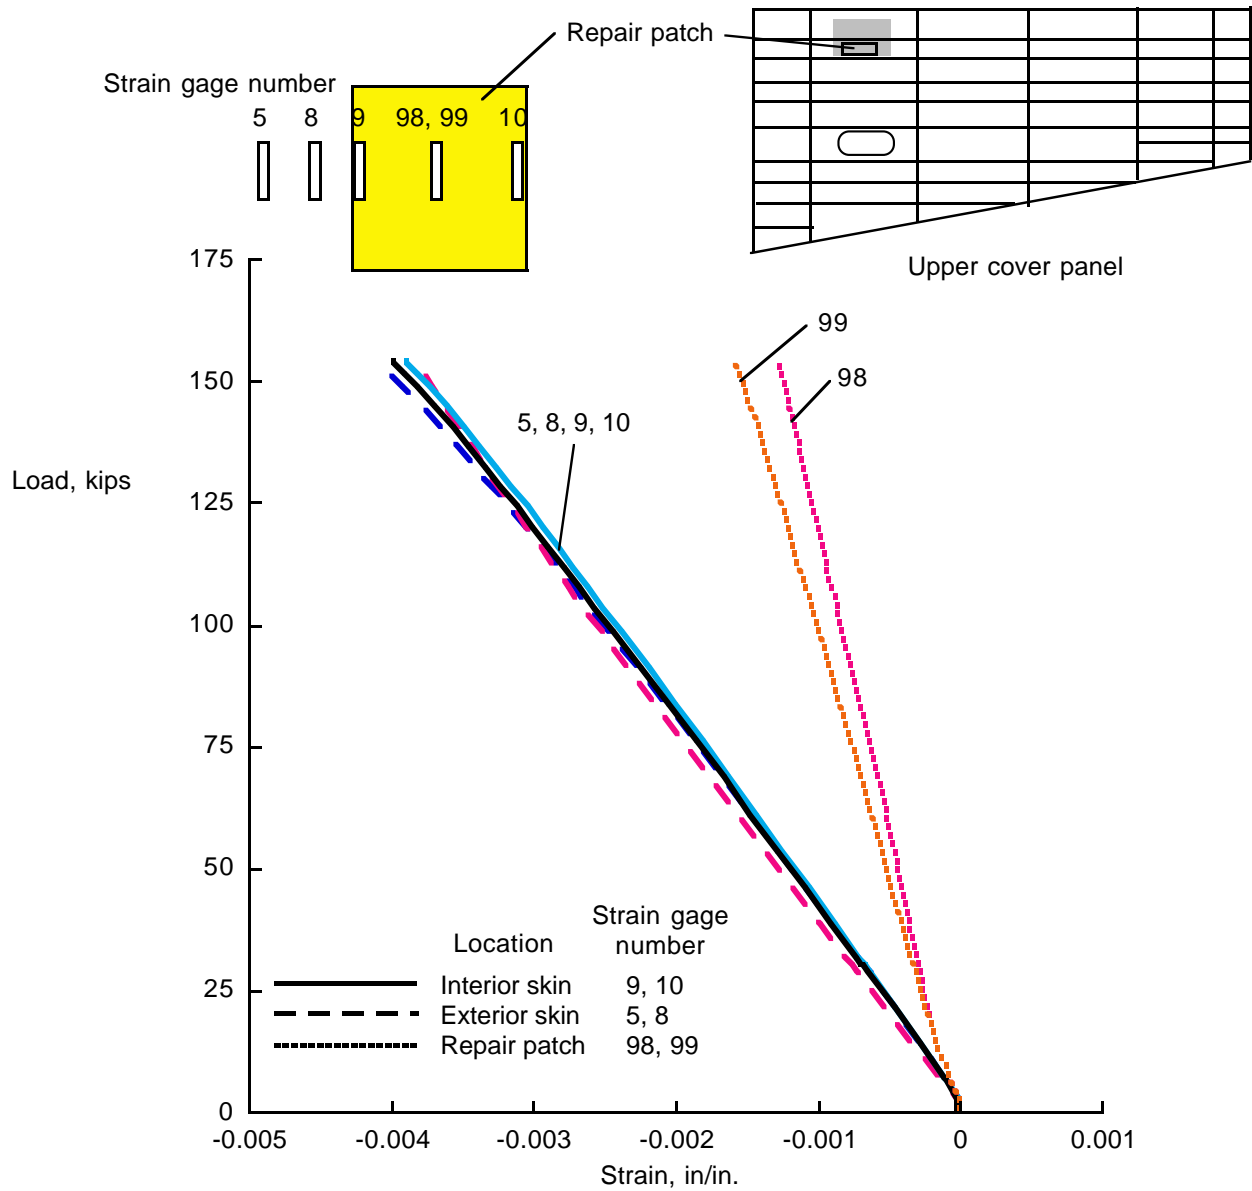
Figure 57. Strains in detectable-damage and repair region during last three tests. All dimensions are in inches.

The strains in the impact-damaged regions are presented in figures 57-61. The strains recorded for the upper cover panel skin in the region of detectable impact damage during three tests of the structure are shown in figure 57. Results are shown for the structure loaded to DLL prior to inflicting damage, the structure loaded to DLL after inflicting damage and the structure loaded to failure after the repair was installed. The strains for the skin and the repair for the final test only are shown in figure 58.

During the loading prior to inflicting damage, the strains in the skin are linear and reach a maximum magnitude of approximately 0.003 in/in. All strain gages in the region to be repaired recorded approximately the same strain. In the loading after visible damage was inflicted, the strains in the skin closest to the damage site were nonlinear in behavior for the entire load range. The maximum strain recorded in the region of visible impact damage is approximately 0.0073 in/in. in a strain gage which is 0.6 inches away from the impact site (strain gage 97). Interior strain gages 1.2 inches away from the impact site (strain gages 9 and 10) recorded the same strains with and without impact damage and with repair. The repair of the structure required the removal of the exterior strain gages closest to the impact site (strain gages 11, 12, 96 and 97). Axial strains measured during the final loading in the repaired bay and the bay adjacent to the repaired bay are shown in figure 58. Strain gages 5, 8, 9 and 10 on the skin recorded approximately the same strain. Strains recorded in the metallic repair are less than half the strains recorded
